NATIONAL TRANSPORTATION SAFETY BOARD

SAFETY RECOMMENDATIONS

ADOPTED APRIL 2002

In reply refer to: A-02-06 and A-02-07

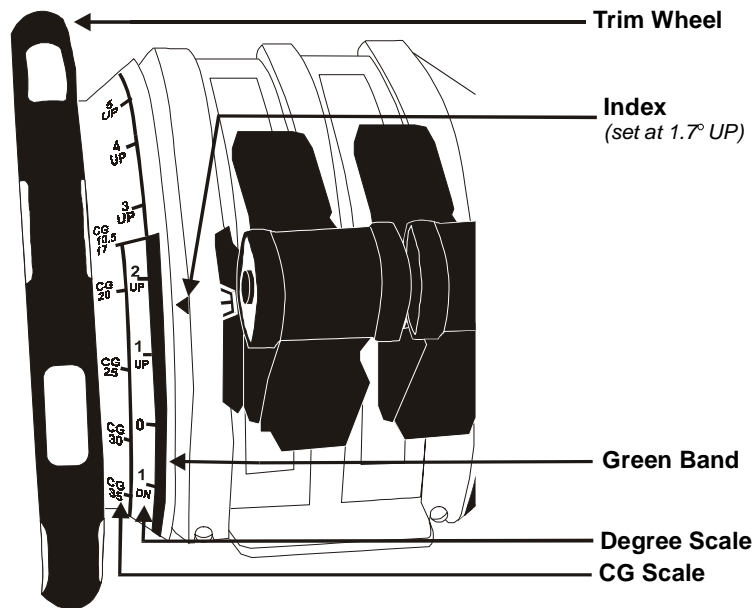
Figure 1. Airbus THS Trim Wheel Indicator Scales.

The trim setting (in degrees) is also shown on the flight control page of the electronic centralized aircraft monitoring (ECAM) display. This display, which correlates to the degree scale on the trim wheel, shows the trim in tenths of degrees followed by “UP” or “DN” to show the corresponding pitch direction of the airplane. On the ECAM display, pitch-up trim values are preceded by a minus sign (“-”), but pitch-down trim values are not preceded by a plus sign (“+”). The ECAM display for this accident would have shown the THS trim as “-1.7°UP.” If the trim had been set correctly, it would have shown as “1.7°DN.”

The Safety Board is concerned that the procedure of using degrees to set and cross-check the THS trim setting has resulted in flight crews improperly setting the trim by using a minus (or UP) value when a plus (or DN) value should have been used. The Safety Board considers pilots of the two carriers who currently follow this procedure to be at risk for incorrectly setting the trim as did the pilots on Northwest flight 985 and the April 2000 Lufthansa flight. This confusion is possible because the degree scale shows some values twice: once to denote pitch up ("UP") and once to denote pitch down ("DN"). The CG scale, however, uses a consecutive series of unique, positive values, which eliminate the opportunity for such confusion.
